Report of
Dam Safety Assessment of Coal Combustion
Surface Impoundments

Kentucky Utilities,
a wholly owned subsidiary of
LG&E and KU Energy LLC

Green River Station, Central City, KY

AMEC Project No. 3-2106-0177-0002

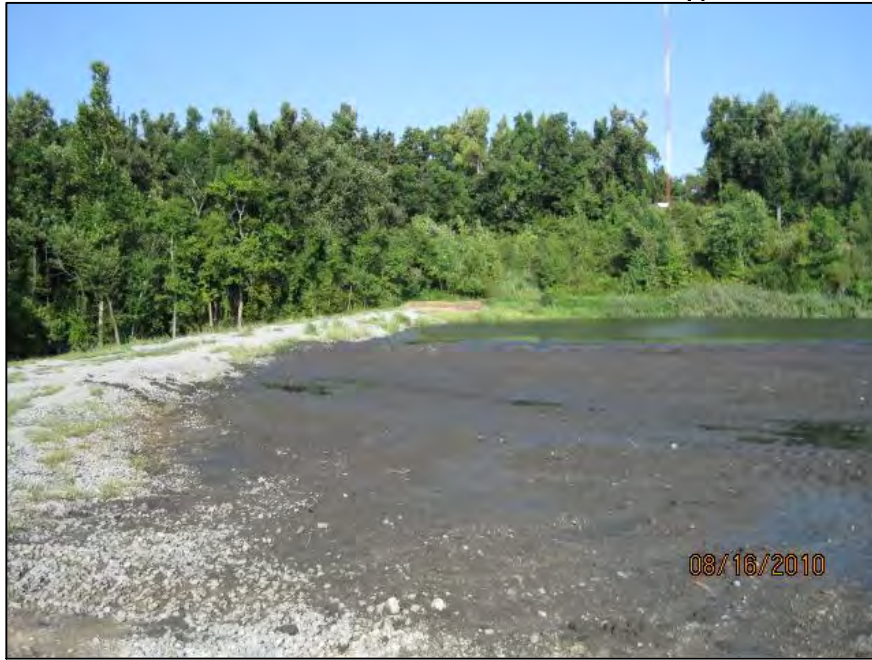
M-1

LOOKING NW AT WEST DIKE - CREST, UPSTREAM SLOPE, POND INTERIOR

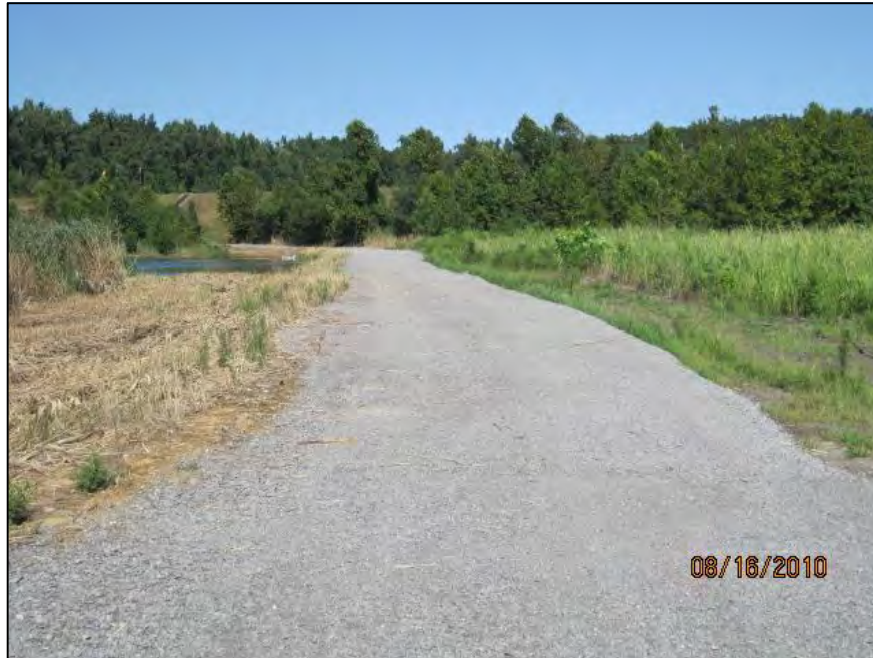
CR-3

LOOKING N AT EAST DIKE (COMMON WITH ASH POND 2)

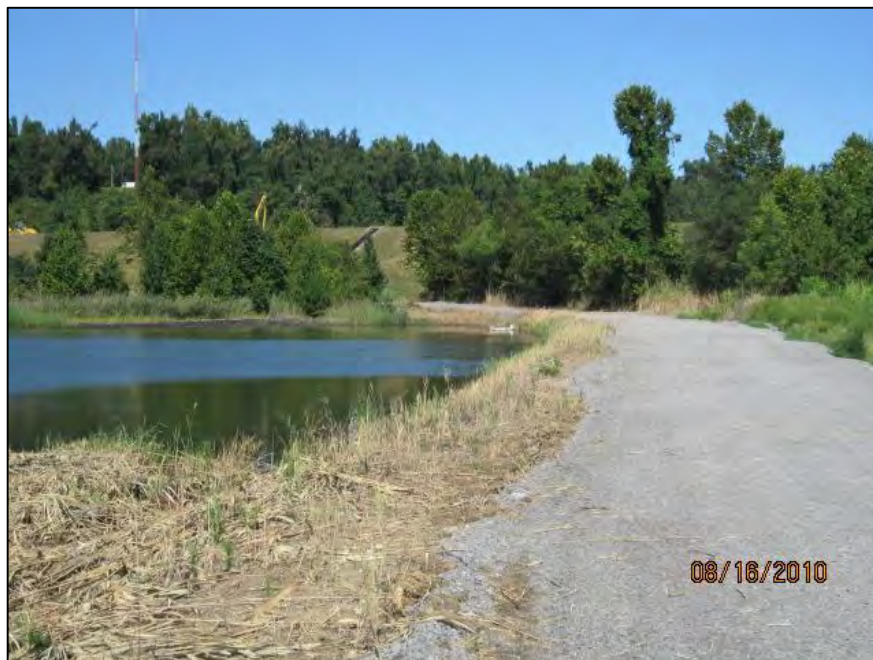
CR-4

LOOKING NW ON EAST DIKE, POND INTERIOR AND TIE-IN IN BACKGROUND

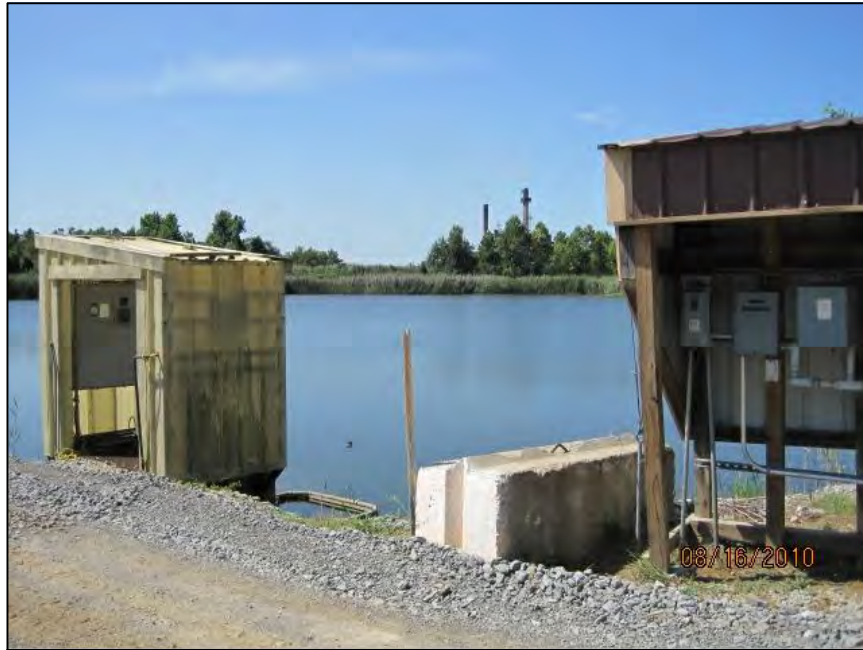
2-11

LOOKING SW FROM NORTHEAST CORNER OF POND AT OUTLET STRUCTURE, CONTROLS AND POND INTERIOR

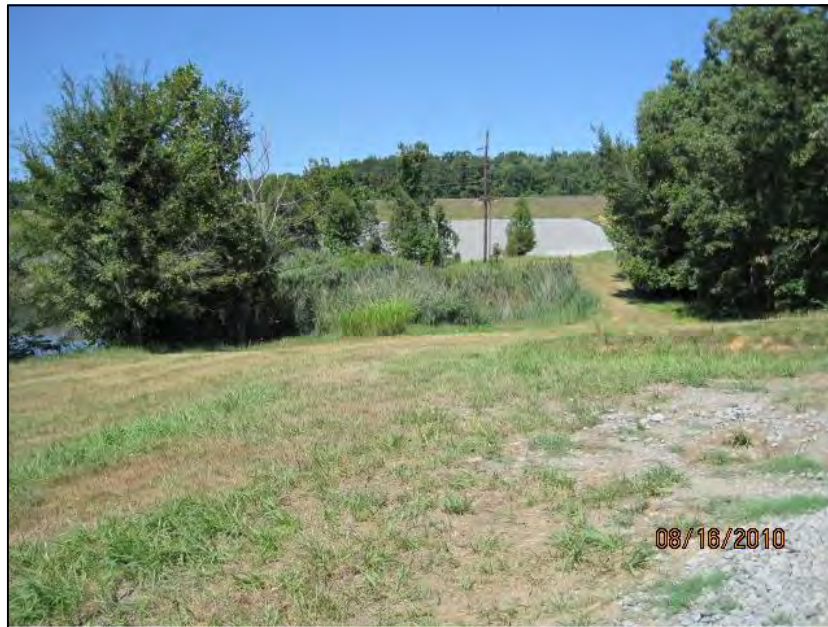
2-15

LOOKING N AT EAST TIE-IN TO NATURAL GROUND, BACKGROUND: EAST BUTTRESS ON MAIN POND SOUTH DIKE

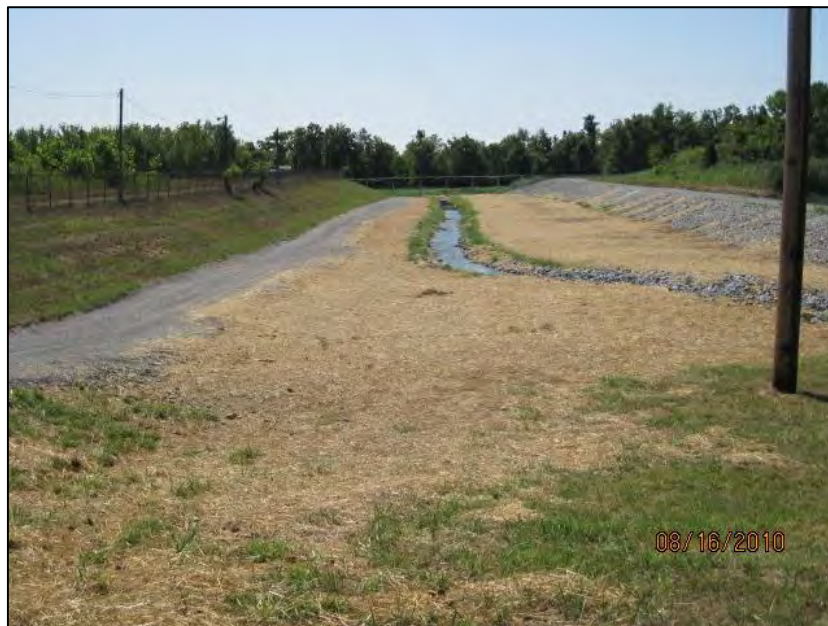
2-16

LOOKING SOUTH AT LEFT: DOWNSTREAM SLOPE WEST DIKE SCRUBBER POND, CENTER: SITE OUTLET DITCH, RIGHT: DOWNSTREAM SLOPE EAST DIKE ASH POND 2

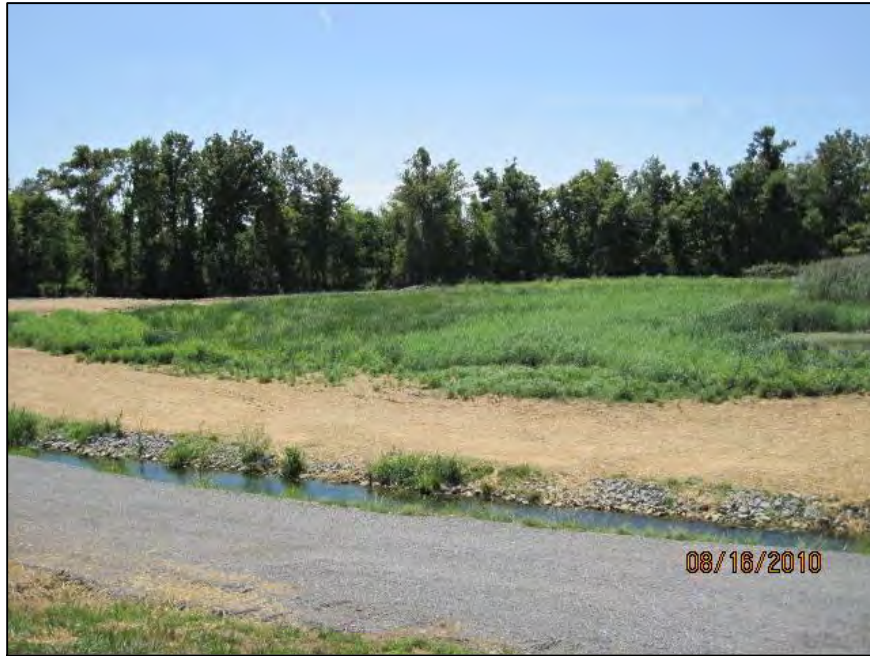
SP-9

LOOKING SOUTH FROM NEAR SOUTHEAST CORNER TOWARD FORMER ASH POND 3
